Inspection Report Minerals Regulatory Program Report Date November 8, 2006

Mine Name: Neal State
Operator Name: Ziegler Chemical and Mineral
Inspection Date: October 31, 2006
Time: 12:15-1:10 PM

M0470063, Neal State Mine, Ziegler Chemical and Mineral

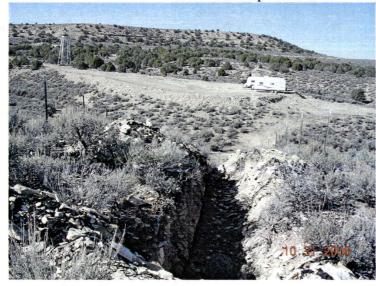
There is an open trench at this site, and I told the operator in the previous inspection that this trench needed to be backfilled, fenced, or otherwise secured. A fence has been installed around the open trench (just visible on the left and right of Photo 1).

Photo 1. The operator has installed a fence on either side of this trench.

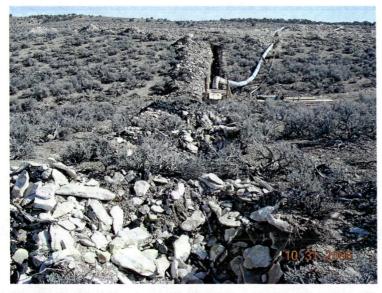
2. Public Safety (shafts, adits, trash, signs, highwalls)
The operator has installed a new shaft with a wood collar to the southwest of the previous workings (center of Photo 2).

Photo 2. This picture shows the Gilsonite vein and the new mine.

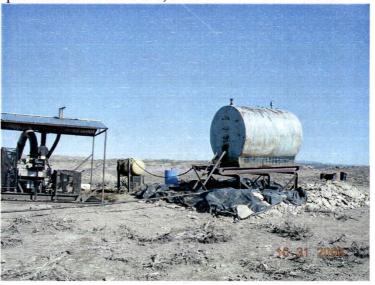
Photo 3. Fuel tank and other facilities at the site.

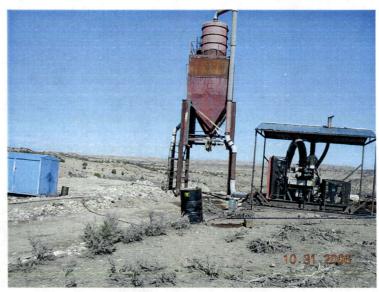
Photo 4. The storage bin.

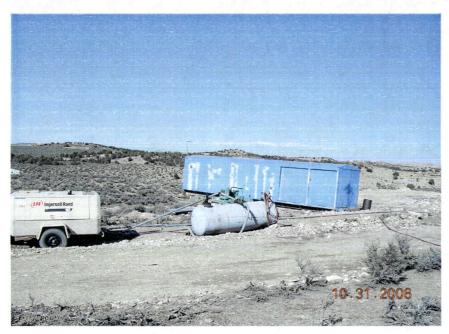
Photo 5. Some of the equipment.

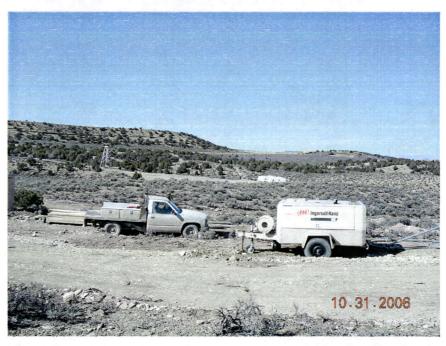
Photo 6. Another view showing some of the equipment. In the distance is a hoist on the Neal #2 Mine pad. Hunters' trailers were parked on the pad at the time of the inspection.

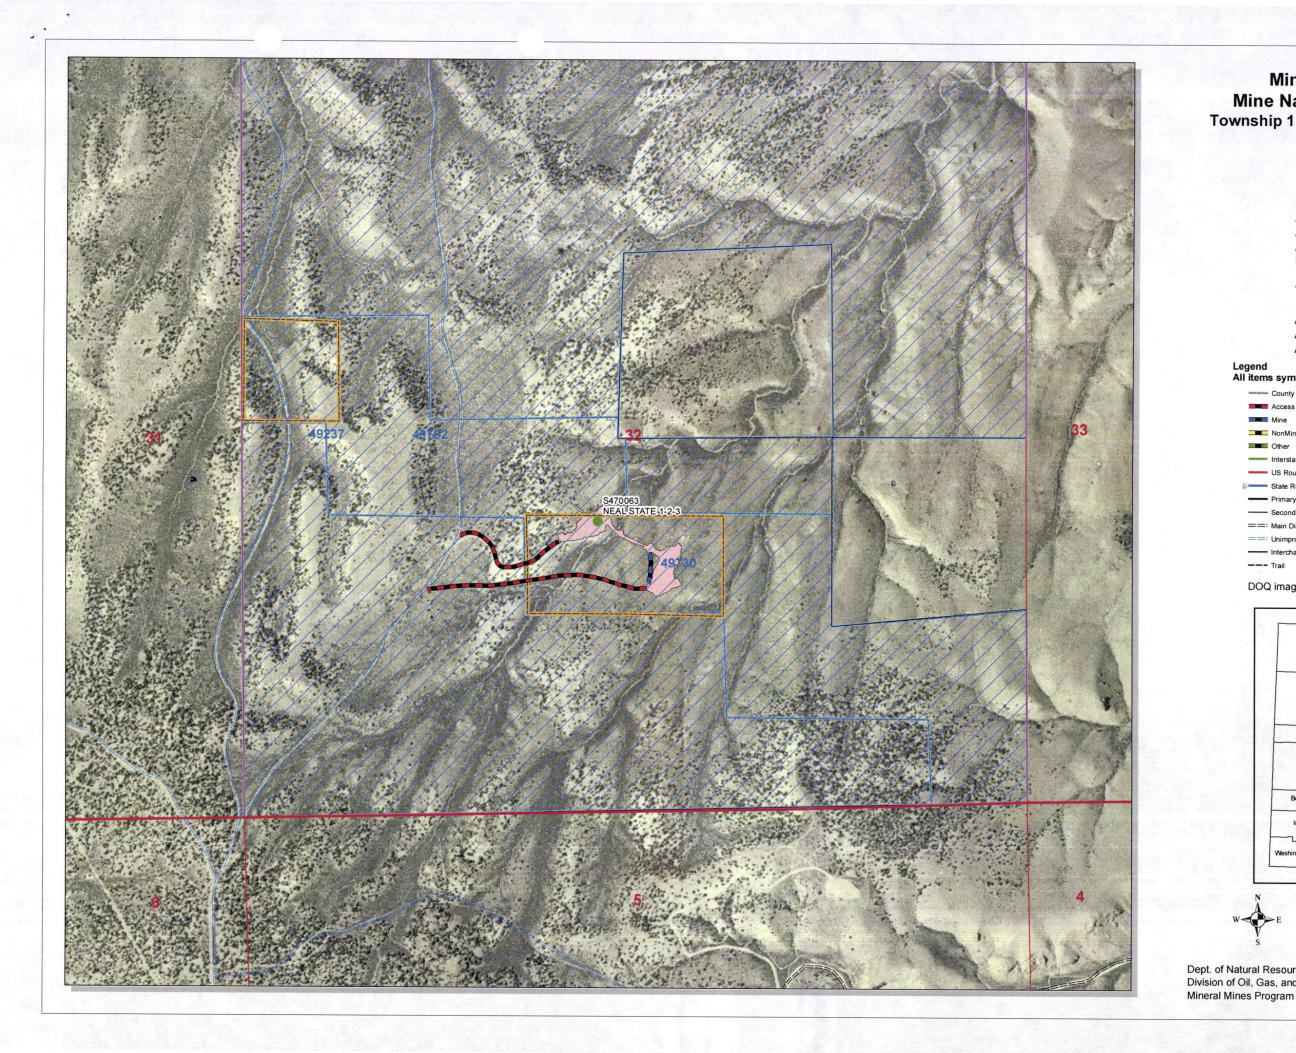
Mine Number: S0470063 Mine Name: Neal Slate 1, 2 and 3 Township 11 S Range 24 E Section 32 SLBM

The attached map shows two access roads. These roads were not included in the acreage figure on the map but should be. The south road is new since the last inspection. Disturbance from the roads is 0.75 acres.

The disturbance acreage figure shown on the attached map does not include the two access roads and does not include the original Neal #1 Mine. The total disturbance shown on the map, including the roads but not including the original Neal #1 site (not mapped), is 3.14 acres.

The operator needs to file an amendment to show the new access road. The amendment needs to also show the total disturbed area acreage for the entire site. While the operator has disturbed more area than shown in the NOI, the surety probably covers enough acreage. This needs to be confirmed.
